Melbourne Airport

Assessment of Organochlorine Pesticides in Airside Surface Soils

REPORT

ELGIN PROJECT REFERENCE: JN16153

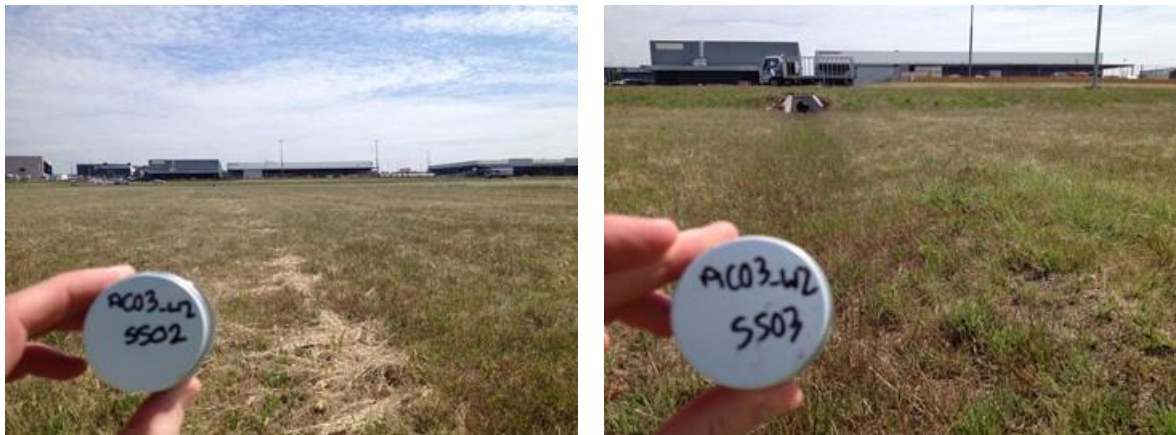
Sampling within Subarea 1 included six locations (SS01-SS06) along spoon drains and swales, adjacent to hardstand verges and within the broader grassed area. The setting of the subarea is illustrated in the photographs below:

Sampled surface soils were described as silty clay, grey to brown and dry to moist.

OC pesticides were not detected at the six sample locations.

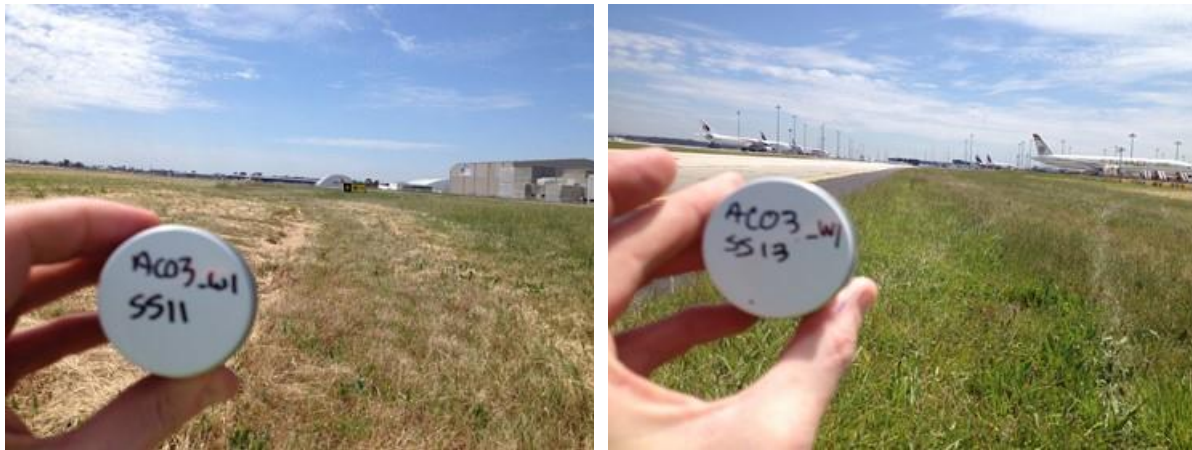
Sampling within Subarea 2 included eight locations (SS07-SS14) along spoon drains and swales, adjacent to hardstand verges and in low points within the broader grassed area. The setting of the subarea is illustrated in the photographs below:

Sampled surface soils were described as silty clay, brown and dry to moist. Minor gravels were also logged in SS12, whilst soils sampled at SS14 in a spoon drain were wet.

OC pesticides were not detected at the eight sample locations.

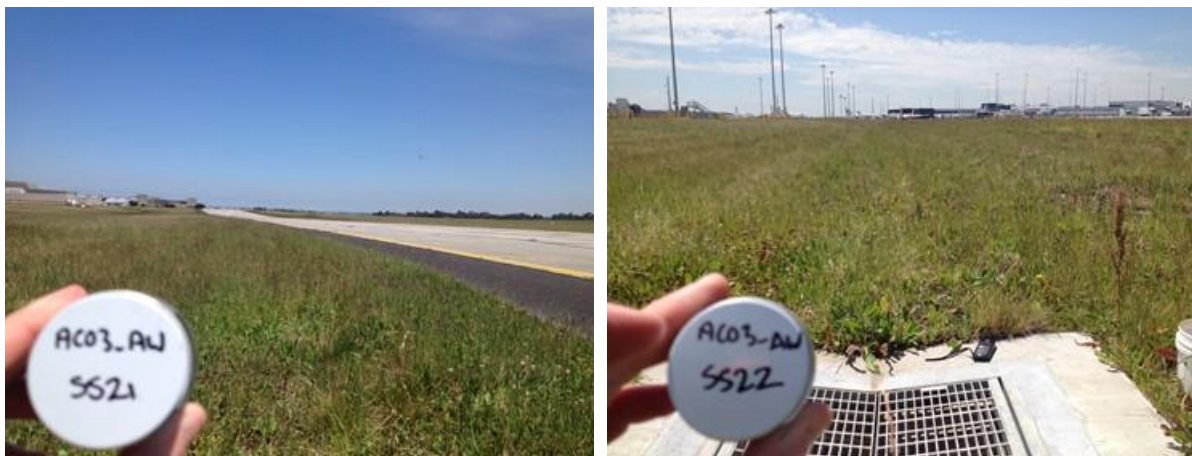
Sampling within Subarea 3 included ten locations (SS15-SS24) along spoon drains and swales, adjacent to stormwater pits and hardstand verges, and in low points within the grassed areas. The setting of the subarea is illustrated in the photographs below:

Sampled surface soils were described as silty clay, brown and dry to moist. Minor gravels were also logged in SS17, whilst soils sampled at SS15 and SS19 in spoon drains were wet.

Dieldrin was detected in surface soils sampled at SS21 (photograph above), located in verge soils adjacent to Alpha Taxiway (**Figure 6**). Dieldrin was reported at SS21 at concentrations ranging from 0.09-0.13mg/kg. This location is nearby to a historical detection of dieldrin in verge soils in 2015 (AC3_SS05), which reported dieldrin at 0.5 mg/kg (**Figure 5**). The result at SS21 is below the

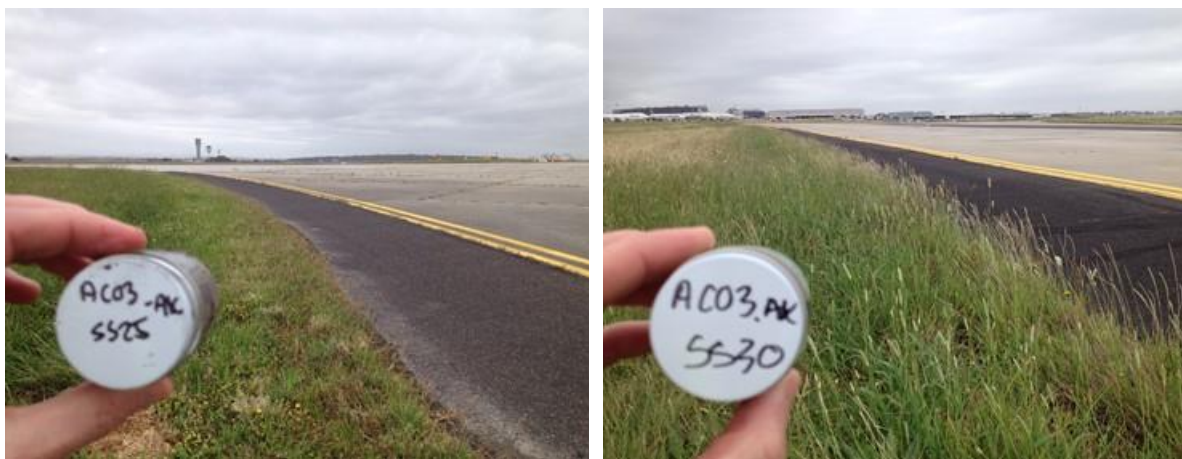
Sampling within Subarea 4 included six locations (SS25-SS30) along spoon drains and swales, adjacent to stormwater pits and hardstand verges, and in low points within the grassed areas. The setting of the subarea is illustrated in the photographs below:

Sampled surface soils were described as silty clay, brown to dark brown and dry to moist. Minor sands were logged at SS25, whilst minor gravels were logged at SS27. Location SS26 was sampled adjacent to an area of reworked surface soils.

Dieldrin was detected in surface soils sampled at SS25 and SS30 (photographs above), at concentrations of 2.3 mg/kg and 0.84 mg/kg, respectively. Endrin was also detected at SS25 at a concentration of 0.02 mg/kg. Both SS25 and SS30 were sampled from verge soils adjacent to taxiways, with SS25 adjacent to Alpha (in north of subarea and across from SS21) and SS30 adjacent to Kilo (in south of subarea and across from SS31 and SS33) (**Figure 6**).

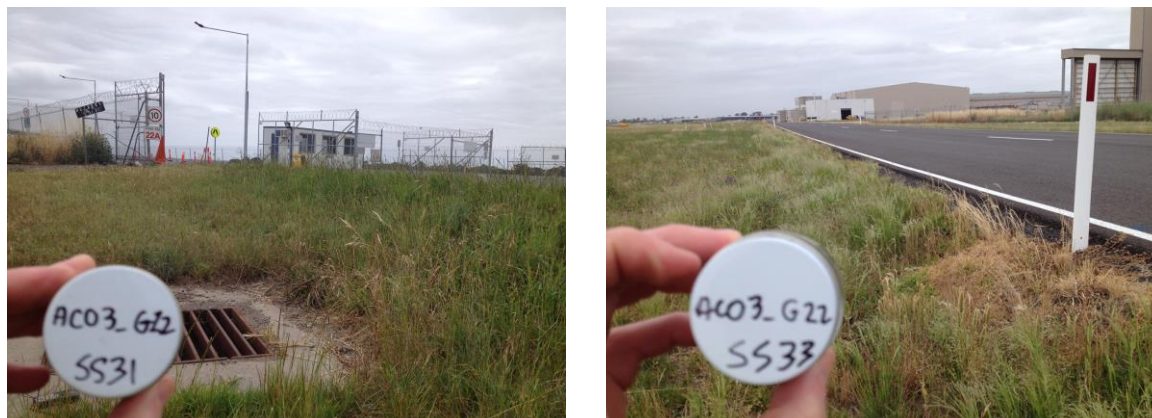
Sampling within Subarea 5 included ten locations (SS31-SS40) along spoon drains and swales, adjacent to stormwater pits and hardstand verges, and in low points within the grassed areas. The setting of the subarea is illustrated in the photographs below:

Sampled surface soils were described as silty clay, brown and dry to moist. Minor sands were also logged at SS31.

Dieldrin was detected in surface soils sampled at SS31 and SS33 (photographs above), both at concentrations of 0.02mg/kg. Both SS31 and SS33 were sampled from grassed swales adjacent to a roadway verge, with SS31 also adjacent to a stormwater pit (**Figure 6**). The locations are nearby to a historical detection of dieldrin in shallow soils, sampled by Prensa near Gate 22 in 2014 (TP05), which reported dieldrin at 0.9-1.3 mg/kg (**Figure 5**).

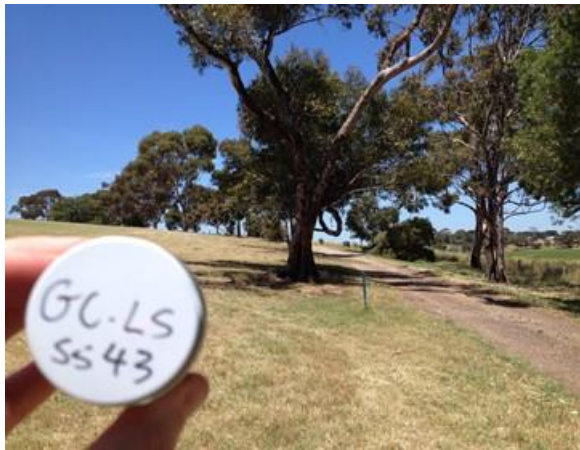
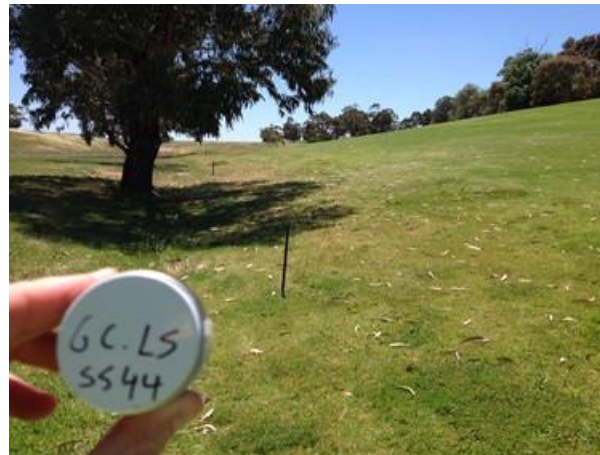
The setting of the subarea is illustrated in the photographs below:

Sampled surface soils were described as silty clay, brown and dry to moist. Minor gravels were also logged in SS43.

OC pesticides were not detected at the six sample locations.

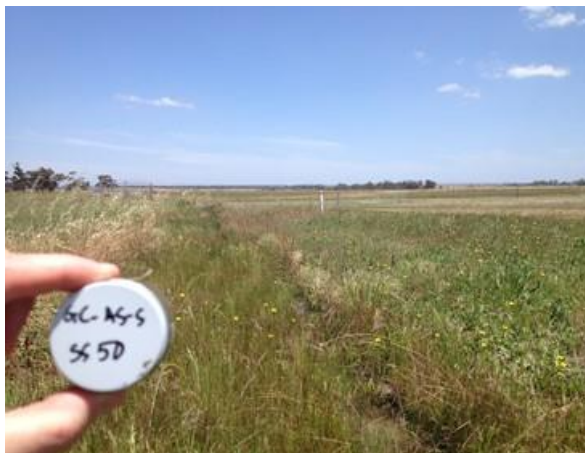
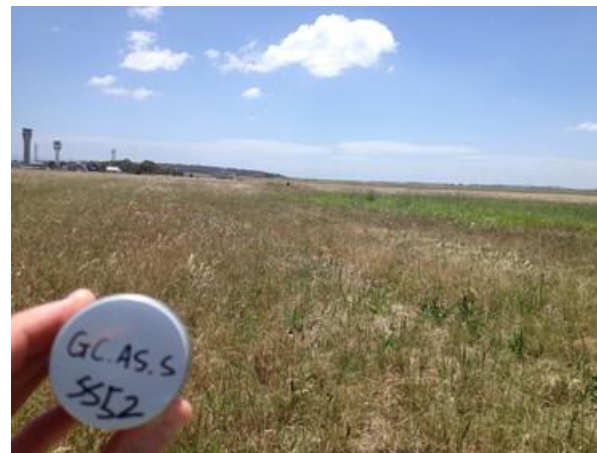
The setting of the subarea is illustrated in the photographs below:

Sampled surface soils were described as silty clay, brown and dry to moist. Surface soils sampled in a spoon drain at SS50 were wet

OC pesticides were not detected at the six sample locations.

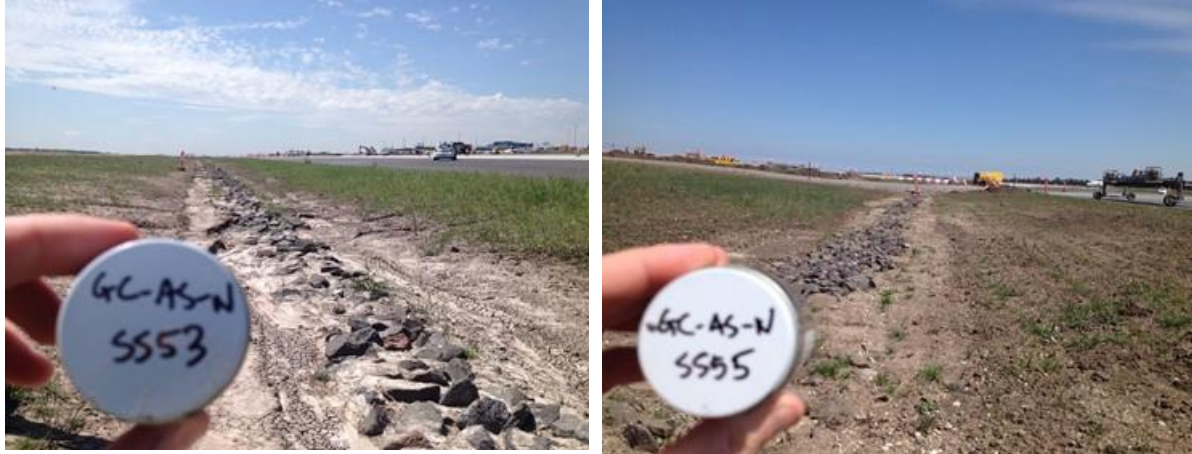
The setting of the subarea is illustrated in the photographs below:

Sampled surface soils were described as silty clay, brown to grey, and dry to moist.

OC pesticides were not detected at the four sample locations.

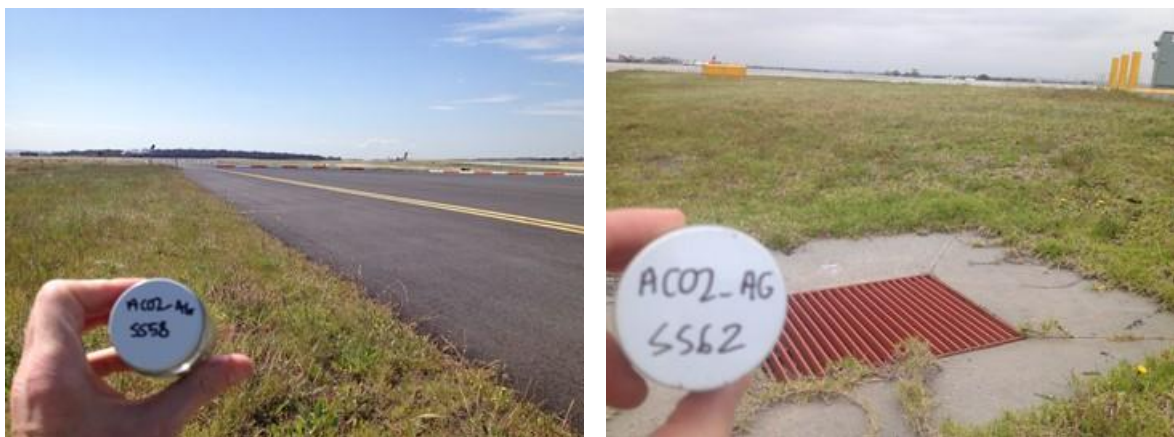
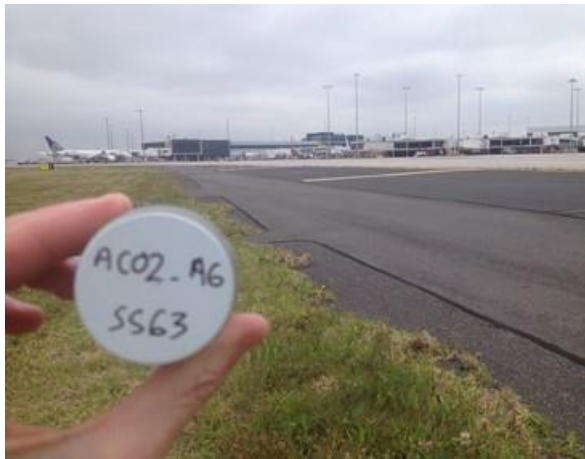
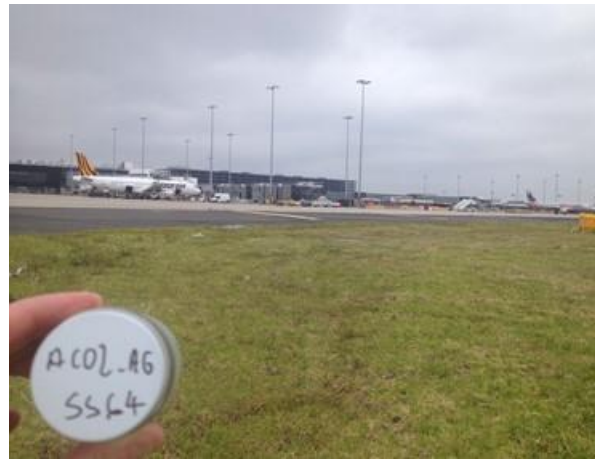
The setting of the subarea is illustrated in the photographs below:

Sampled surface soils were described as silty clay, brown to grey, and dry to moist. Minor gravels were also logged in SS64.

Dieldrin was detected in surface soils sampled at SS63 and SS64 (photographs above), which are both located in the grassed island west of the Terminal Apron, and which were sampled from surface soils on the verge of the Apron hardstand (**Figure 6**). Dieldrin was detected at 0.33 mg/kg at SS63 and 1.0 mg/kg at SS64, with both results exceeding the accepted limit/trigger value (area of environmental significance) of 0.2 mg/kg.

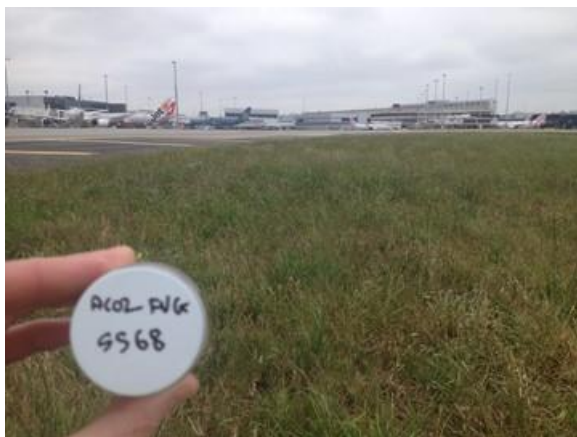
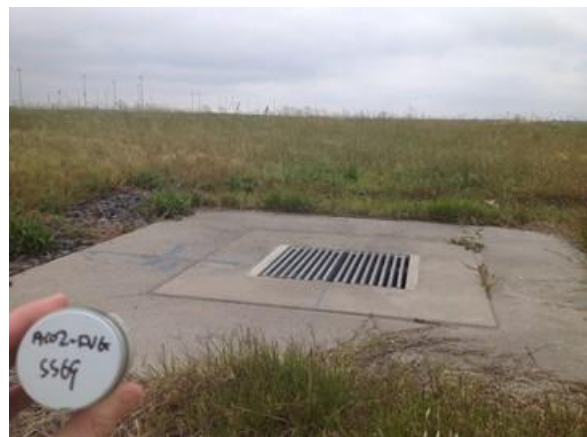
The setting of the subarea is illustrated in the photographs below:

Sampled surface soils were described as silty clay, brown to grey, and dry to moist. Minor gravels were also logged in SS71.

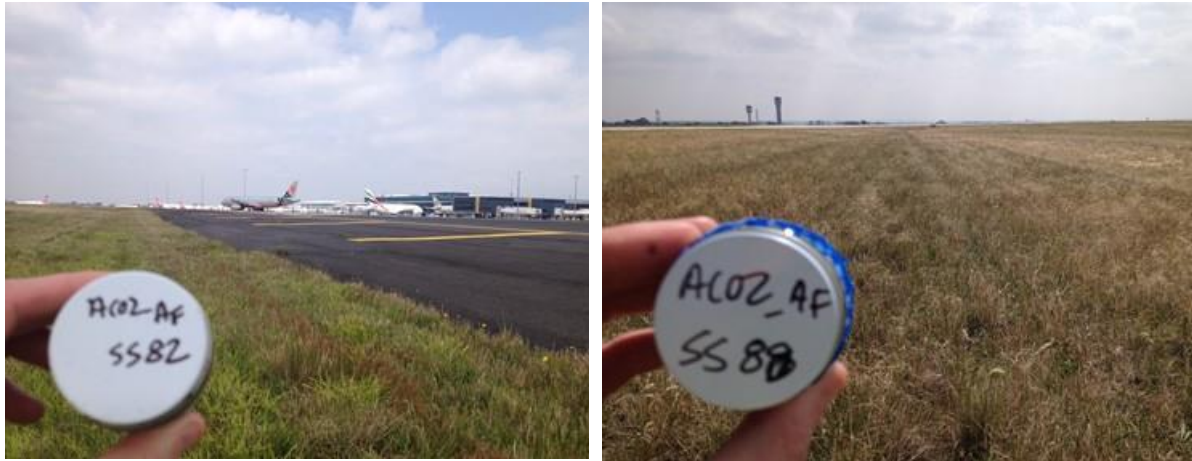
The setting of the subarea is illustrated in the photographs below:

Sampled surface soils were described as silty clay, brown to grey, and dry to moist. Soils were wet at SS86 and SS89, located in spoon drains.

OC pesticides were not detected at the 14 sampling locations in the subarea.

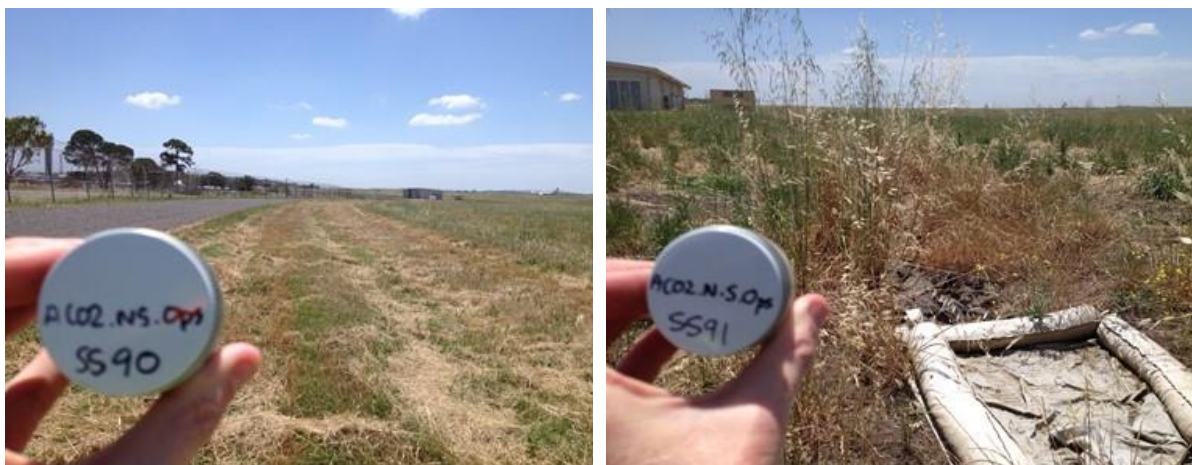
The setting of the subarea is illustrated in the photographs below:

Sampled surface soils were described as silty clay, brown, and dry.

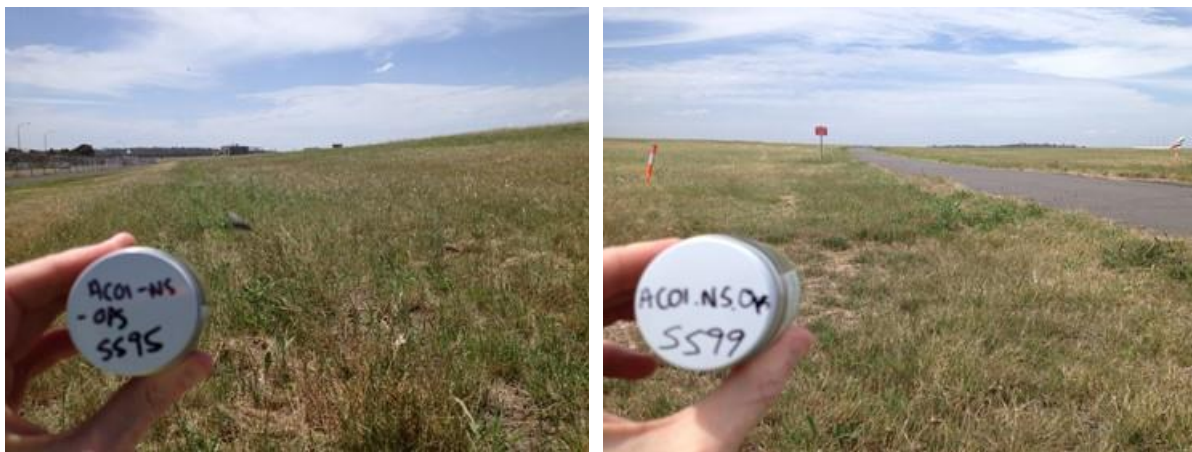
The setting of the subarea is illustrated in the photographs below:

Sampled surface soils were described as silty clay, brown, and dry.

OC pesticides were not detected at any of the five sampling locations in the subarea.

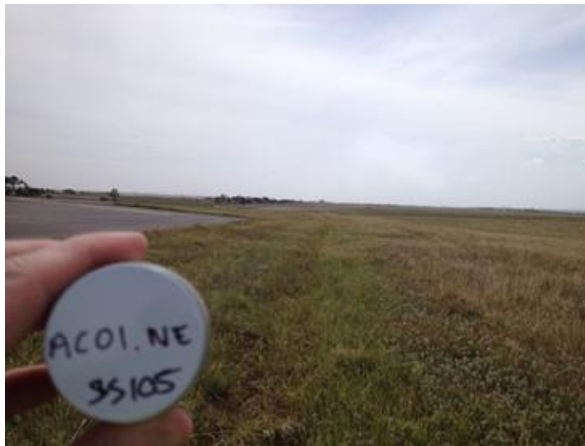
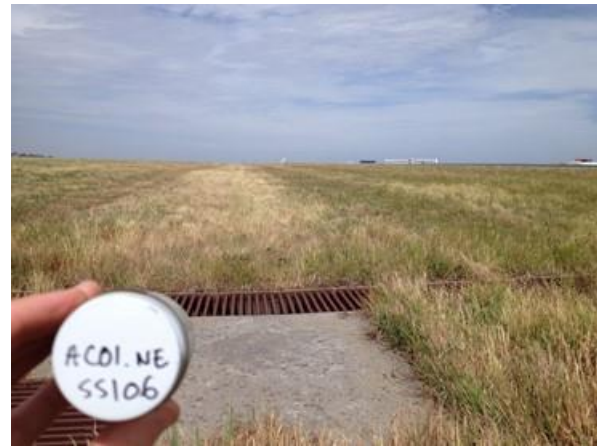
The setting of the subarea is illustrated in the photographs below:

Sampled surface soils were described as silty or gravelly clay, brown, and dry.

OC pesticides were not detected at the seven sampling locations in the subarea.

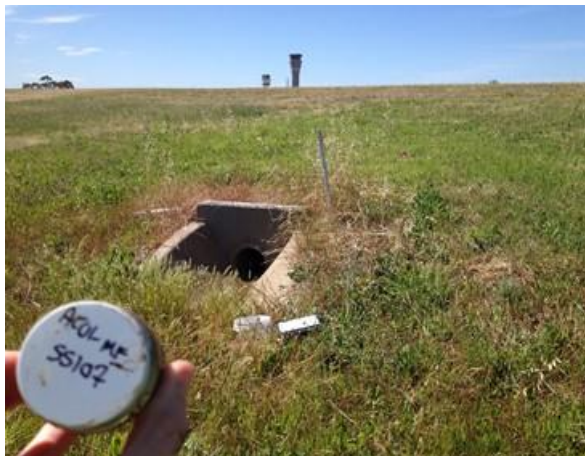
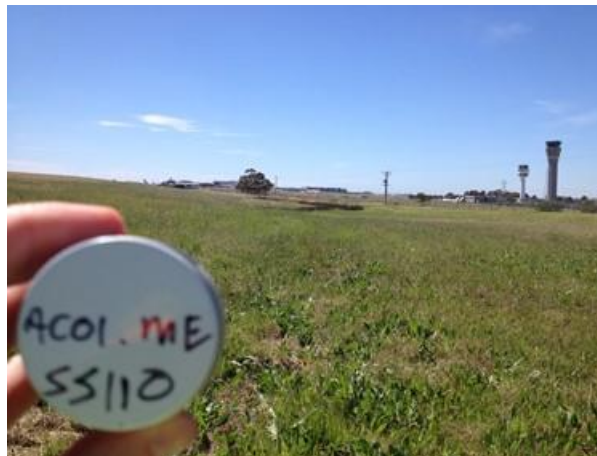
The setting of the subarea is illustrated in the photographs below:

Sampled surface soils were described as silty clay, brown, and dry. Soils at SS107 and SS111 were sampled adjacent to culverts and were wet.

OC pesticides were not detected at the five sampling locations in the subarea.

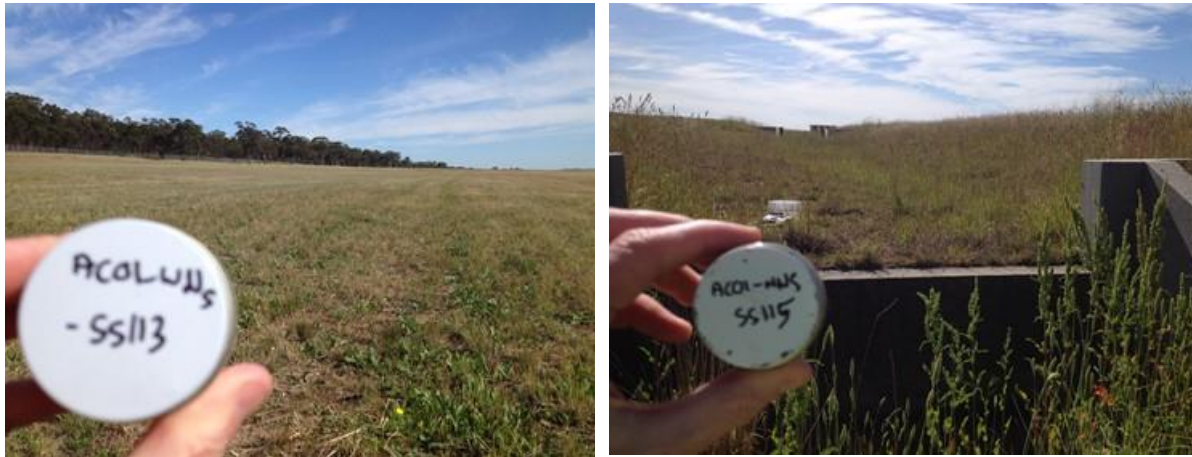
The setting of the subarea is illustrated in the photographs below:

Sampled surface soils were described as silty clay, brown to grey, and dry to moist.

OC pesticides were not detected at the ten sampling locations in the subarea.
